Low Frequency Playground Inspection ver. 2

| Record: 811 | |
|--|---|
| Inspected By | <i>Nancy A. White, CPSI Certification No. 38108-0520</i> |
| Date and Time | <i>2021-08-06 11:15:57</i> |
| Name of Park | <i>Jenkins Elementary</i> |

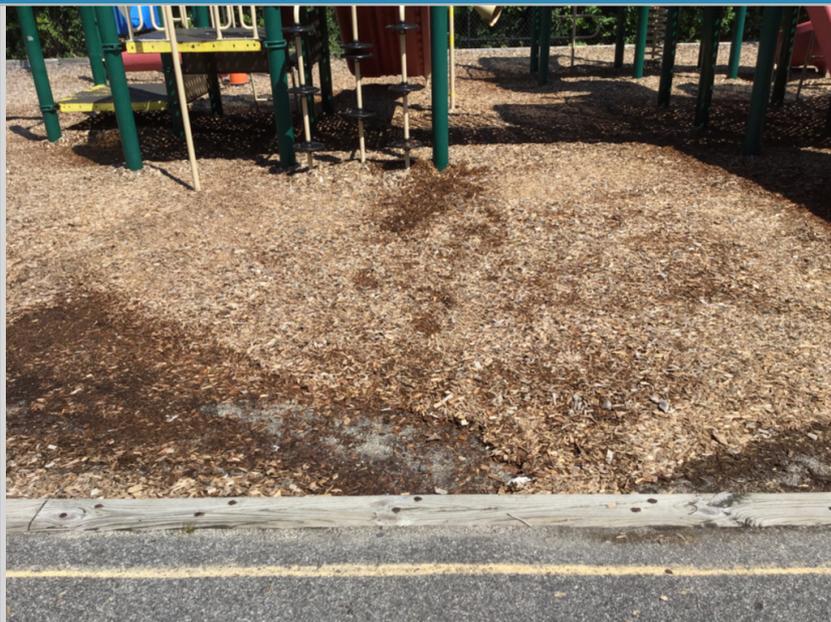
Not at Min. Depth for Fall Height of Particular Equipment

The photo shows two areas of woodfiber with different depths. All of the loose fill in high traffic areas is too low. Yet, there are a few areas where it is deep enough (this is shown by the post). There is also a drainage issue. I would recommend removal of all of the fiber and begin again - and also check the drainage concern. All hazards categories are present on the structure play area,

1 - Loss of life, permanent disability or body part

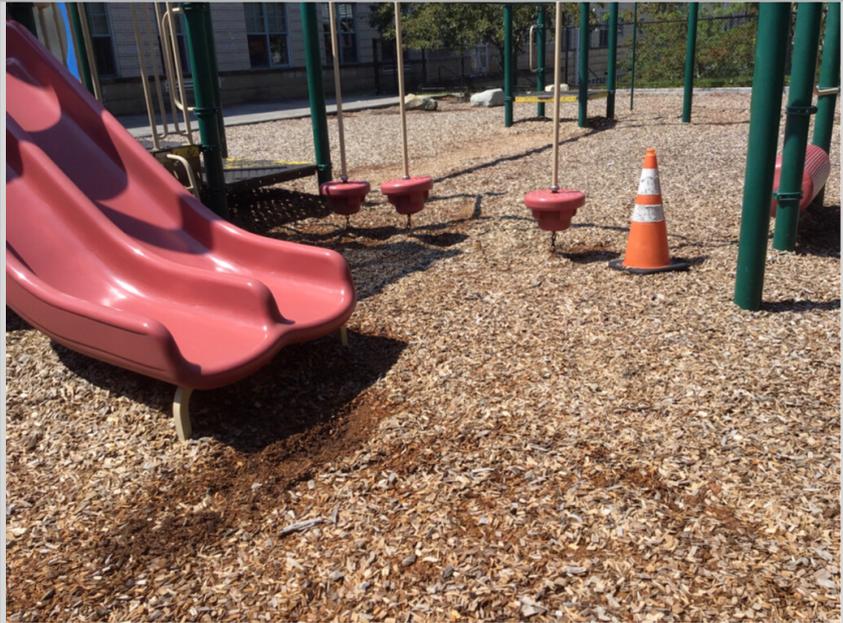
Not at Min. Depth for Fall Height of Particular Equipment

This photo shows two more areas where there is not enough surfacing. The bottom of the slide has 4" and the moving bridge has 'very little' - as seen by the footers above grade.

1 - Loss of life, permanent disability or body part

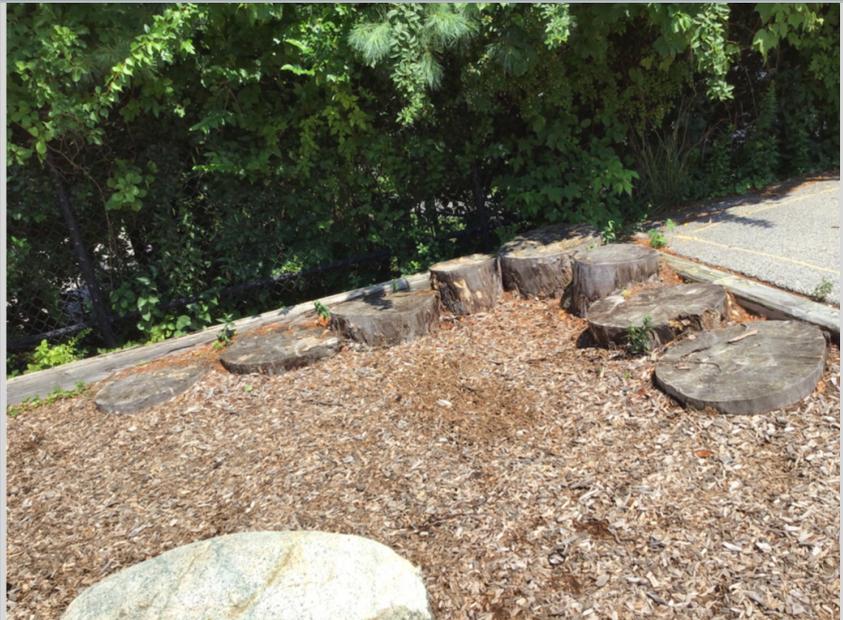
Presence of Moss, Algae, Grass, or Other Vegetation

Grass, weeds, and rotted logs are present.

3 - Minor (non-disabling) injury/Non-compliant

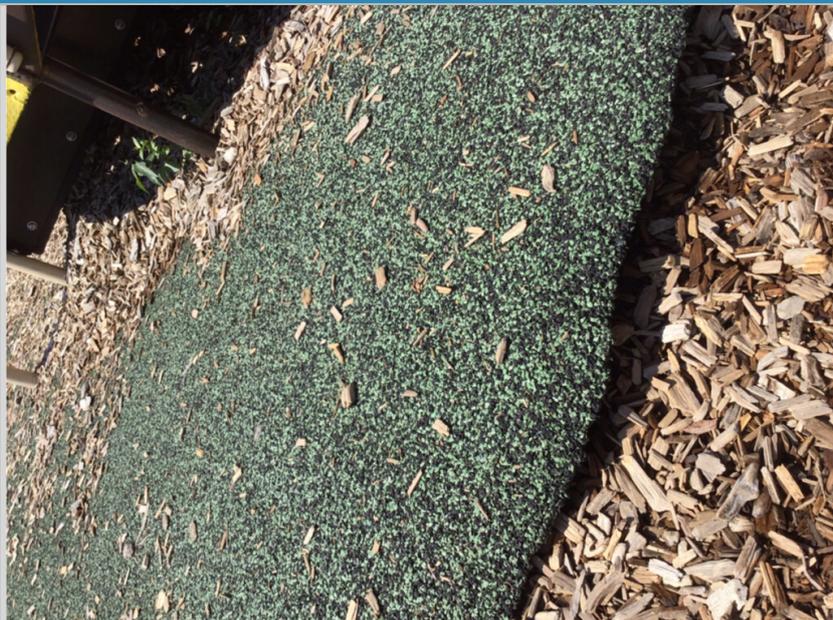
Tile Loose, Cracked, Curling, etc.

'Curling and ripping' PIP.

2 - Serious injury or illness resulting in temporary disability

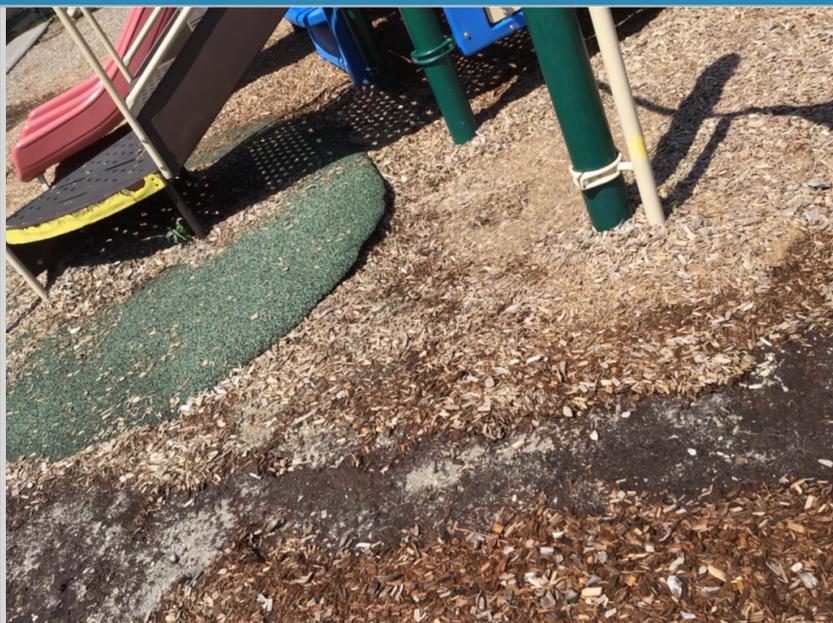
Slip/Tripping Hazards

Tripping hazard present is due to a lack of loose fill - not equal to the PIP. Further, PIP was not beveled down enough - a child can trip 'into' the structure. Additional photos indicate that

the materials are not firm to edges.

The PIP is suppose to have a SBR cushion under the top EDPM colored granules. None was installed.

| Hazard Level | <i>1 - Loss of life, permanent disability or body part</i> |

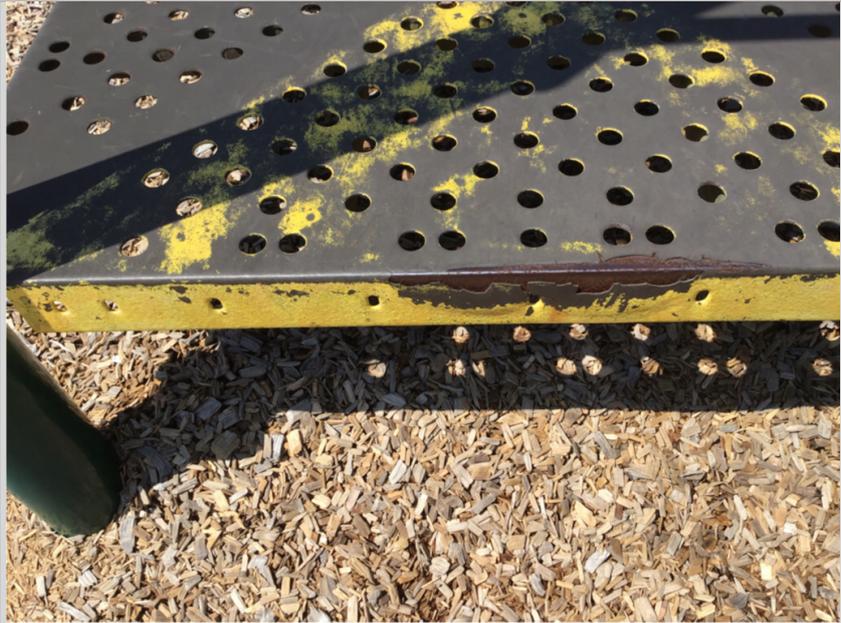
Structural Integrity of Mounting and Foundation Photo

Transfer module (deck) is failing; it's integrity has been compromised.

1 - Loss of life, permanent disability or body part

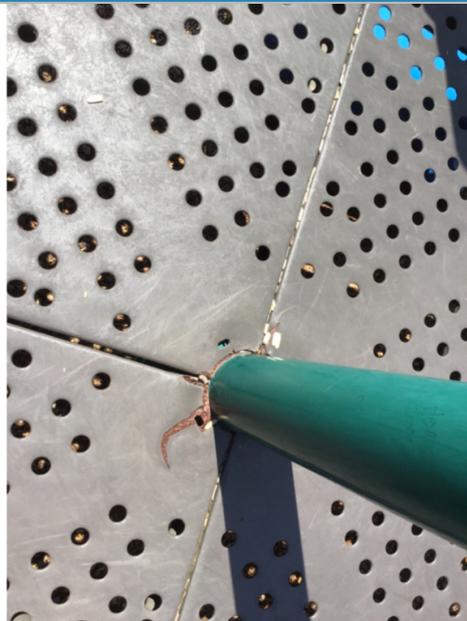
Cracked, gaps, missing parts, welds pitting Photo

All of the decks are in poor condition. There is 'peeled off' PVC, rusting has occurred and 'eating' into the steel. There is 'no fix' for any of them. The structural decks are compromised. If one deck fails, they all will fail soon after. This photo is of a

'crucial intersection' on the structure.

1 - Loss of life, permanent disability or body part

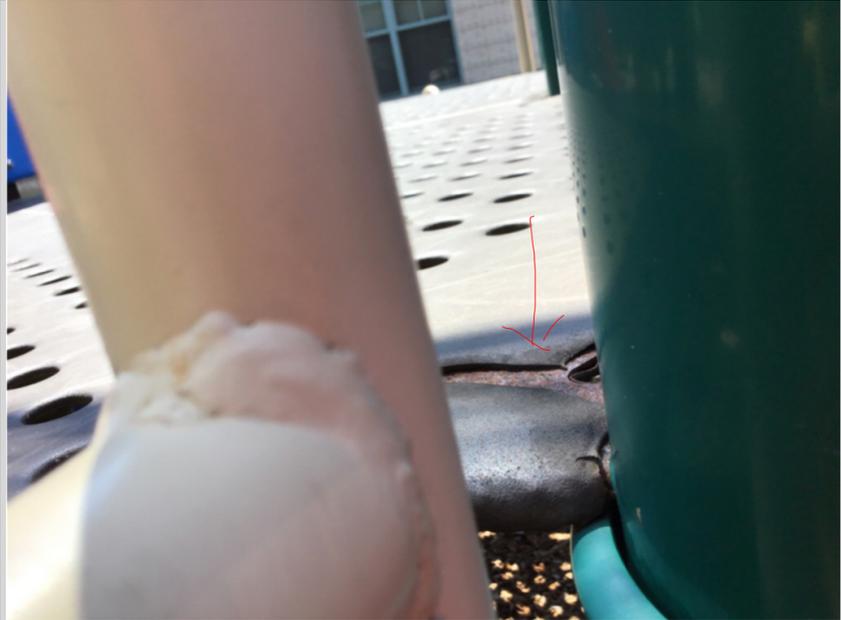
Cracked, gaps, missing parts, welds pitting Photo

There are rusted & flaking areas (on decks) where there is no where for the water to drain. This is extremely dangerous - if a child fell, or tripped into one; it could cause a deep gash or head trauma.

1 - Loss of life, permanent disability or body part

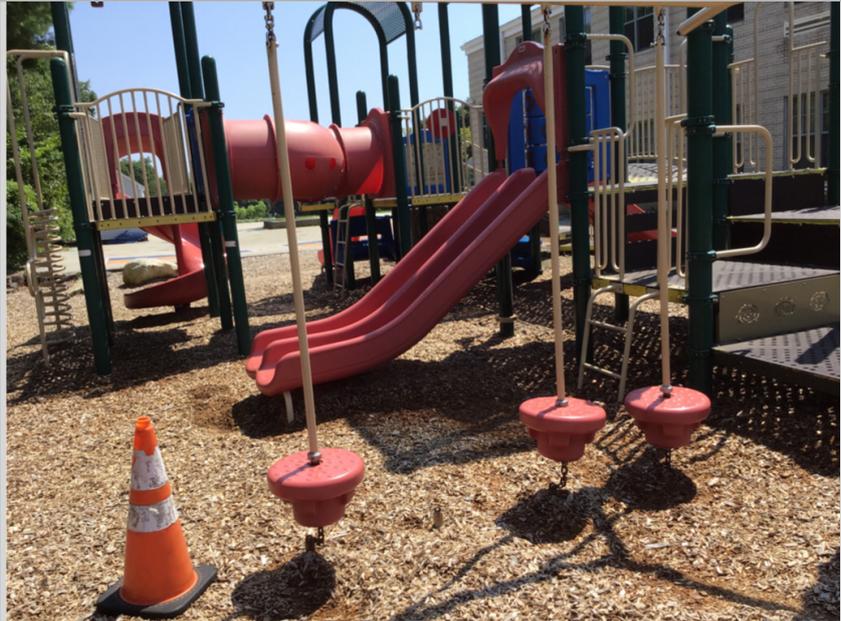
Cracked, gaps, missing parts, welds pitting Photo

The moving pod bridge has two supports broken and missing. Ground supports are sharp and the chain is failing at the bottom of the remaining pods.

2 - Serious injury or illness resulting in temporary disability

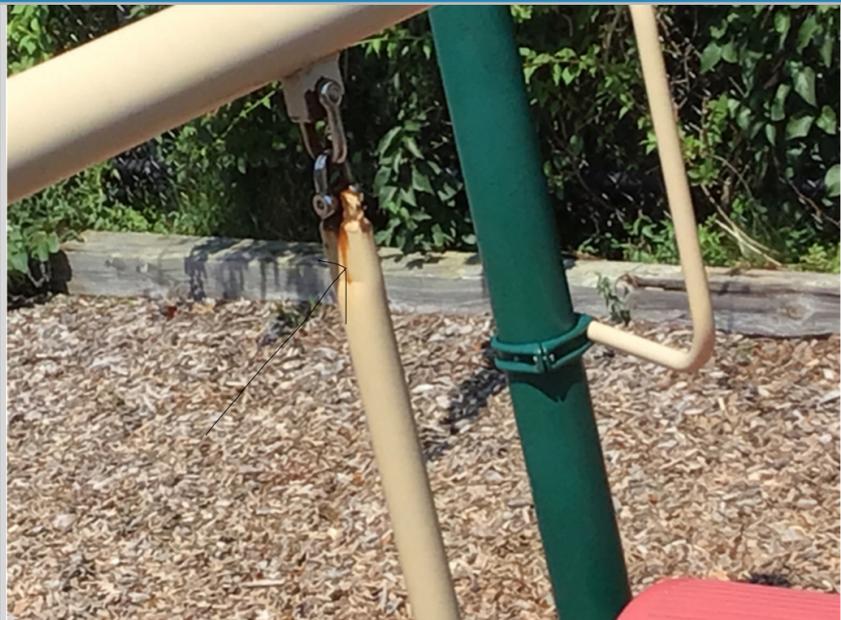
Paint - cracked, peeling, chipping, rusting Photo

There is peeling paint with rust settling in; the component gets compromised when this happens.

2 - Serious injury or illness resulting in temporary disability

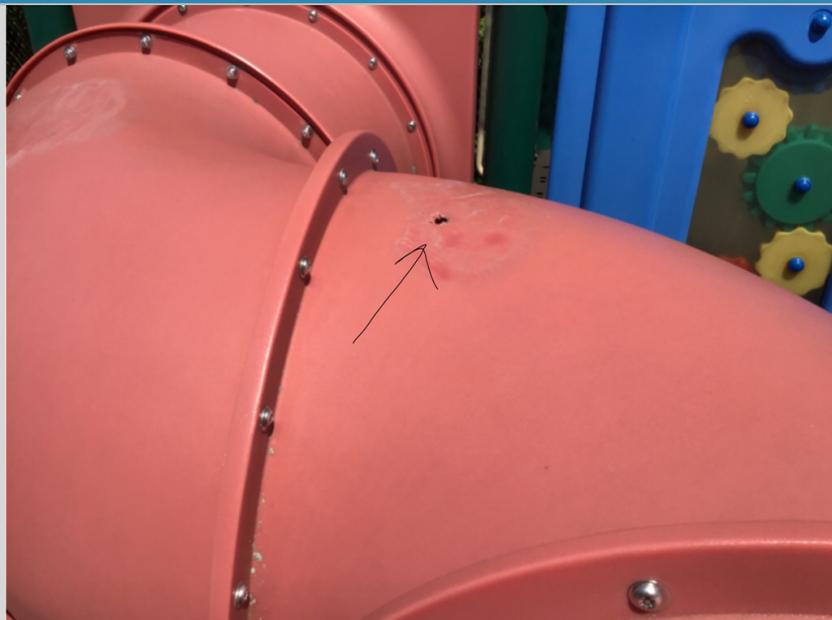
Paint - cracked, peeling, chipping, rusting Photo

The tunnel has a hole; it may have been burned. Watch for cracking and if it starts, replace asap.

0 - Non-Hazard - For Your Information

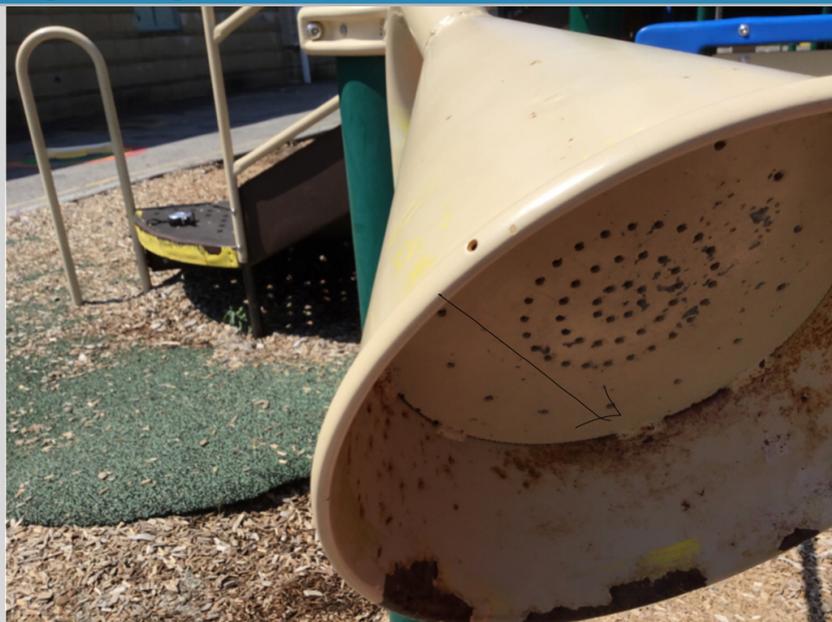
Paint - cracked, peeling, chipping, rusting Photo

| Comments | <i>Both talk tubes are rusted from peeled paint.</i> |
| Hazard Level | <i>3 - Minor (non-disabling) injury/Non-compliant</i> |

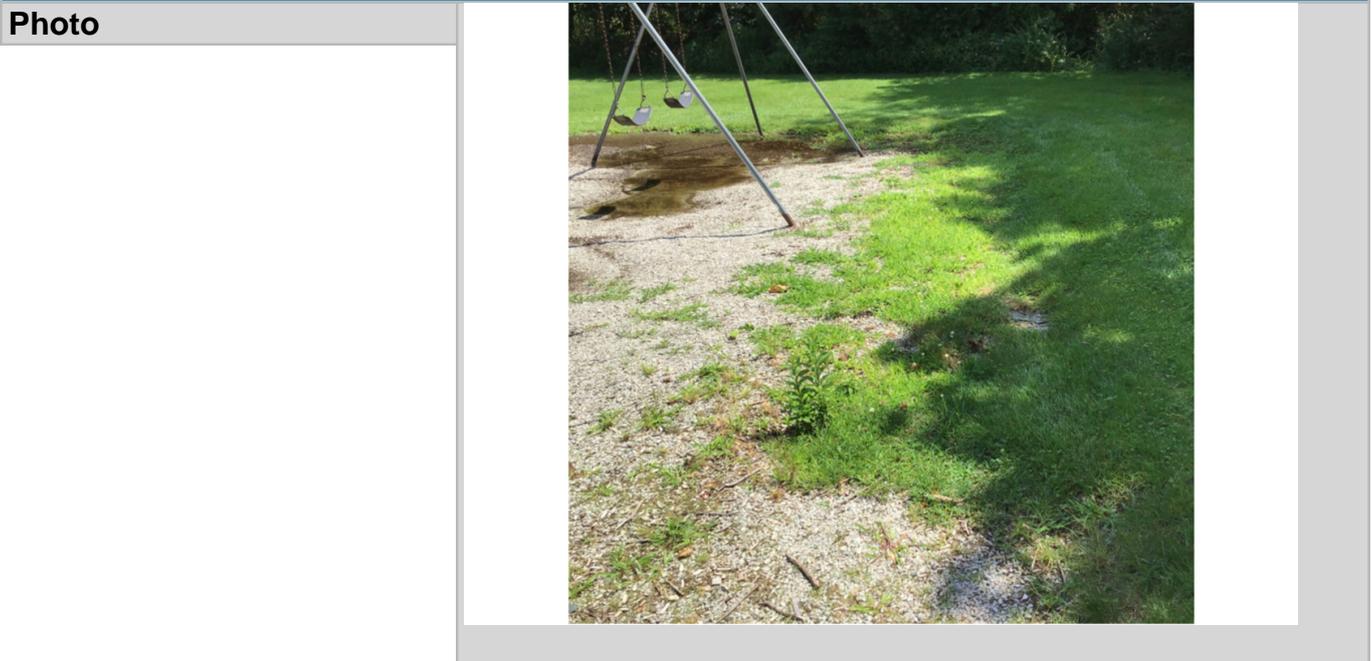
Use Zone Photo

| Comments | <i>The swings in the area below the playground do not have a proper use zone. Remove weeds and add proper resilient surfacing.</i> |

Hazard Level 1 - Loss of life, permanent disability or body part

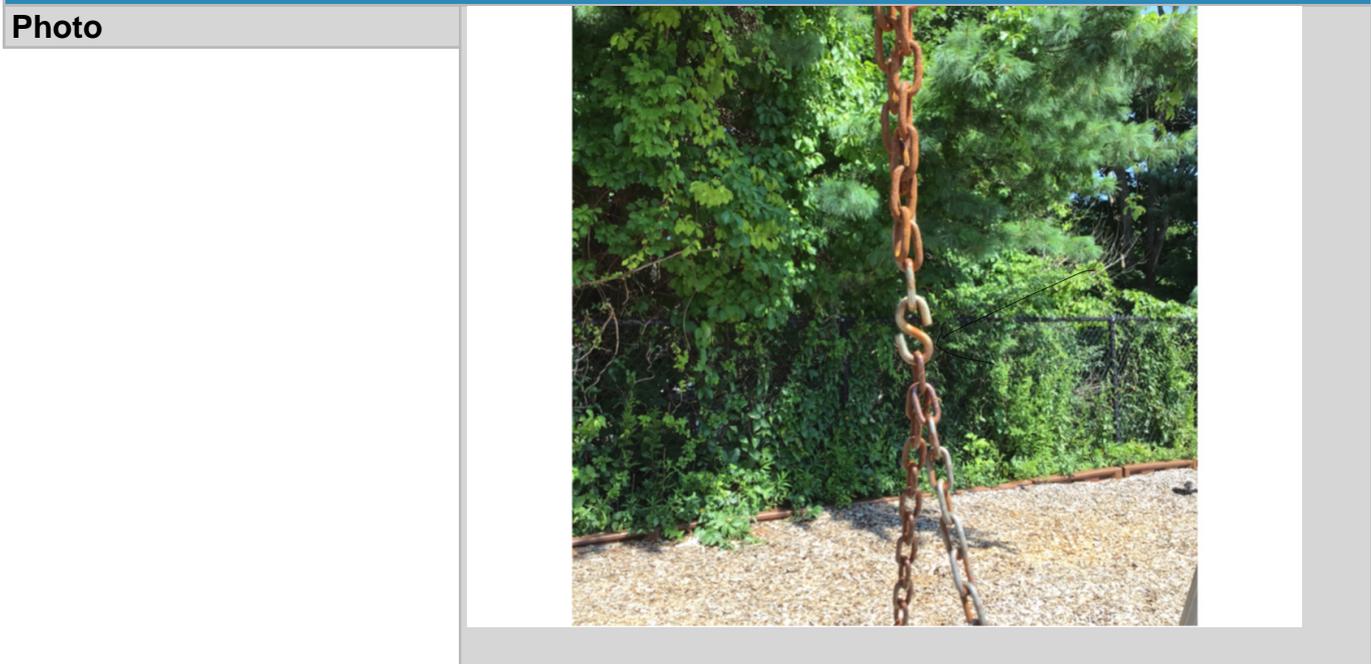
Hardware - (corrosion, worn, loose, missing)

Comments "S" hook wear. Hardware for upper swings should be replaced. The rubbing of chain to hardware wears down the metal. NOTE all "S" hooks must be closed.

Hazard Level 2 - Serious injury or illness resulting in temporary disability

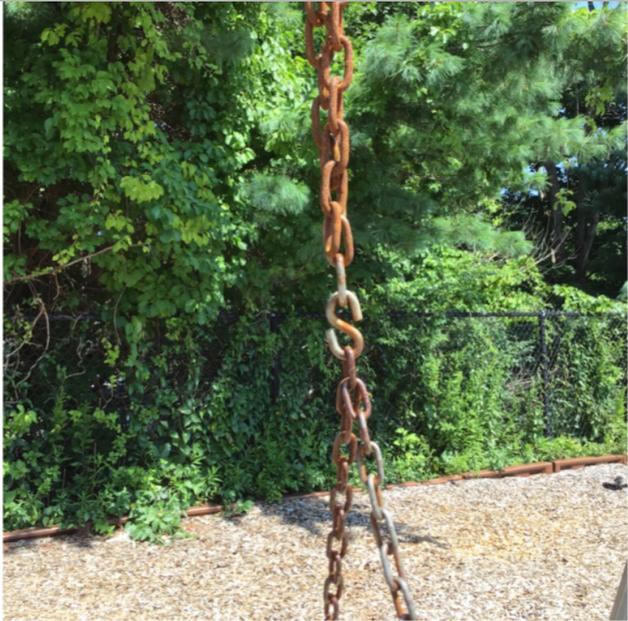
Chain - (galvanized rusted, snapped coated cracked/stripped) Photo

| Comments | <p><i>Same photo as above. The rusted chain and excess chain needs to be removed.</i></p> |
| Hazard Level | <p><i>2 - Serious injury or illness resulting in temporary disability</i></p> |
